PJ'S BASS LAKE DAM  
ST FRANCOIS COUNTY, MISSOURI  
MO 31189

## PHASE 1 INSPECTION REPORT NATIONAL DAM SAFETY INSPECTION

JUNE 1981

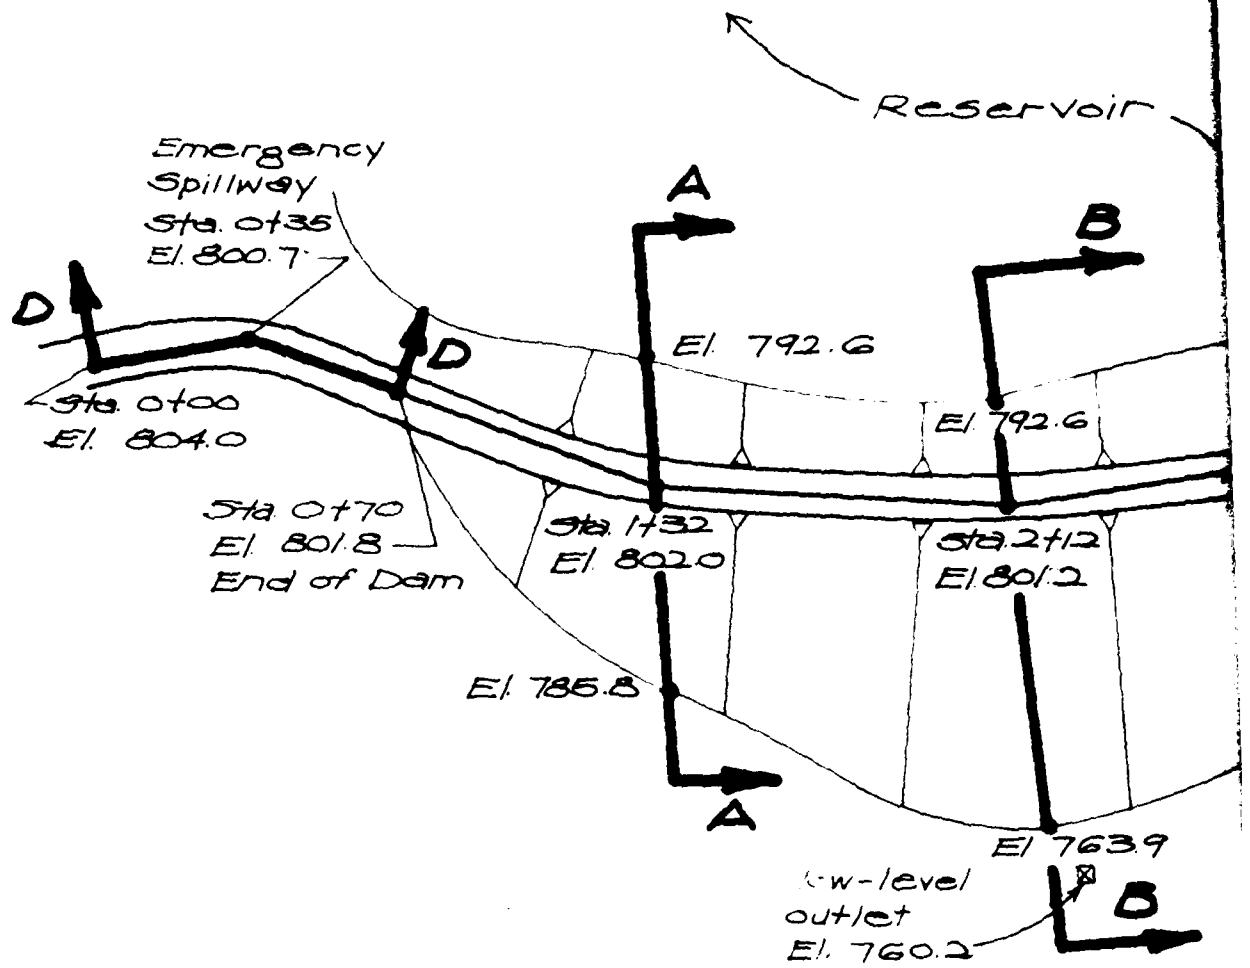
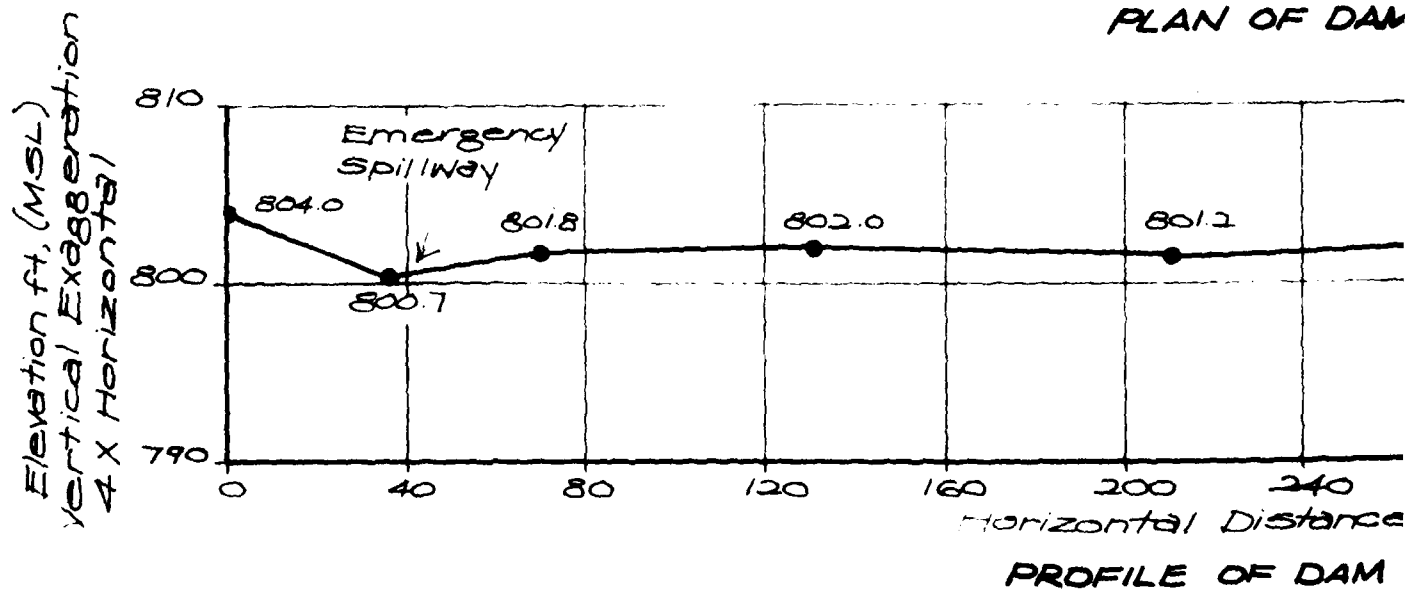
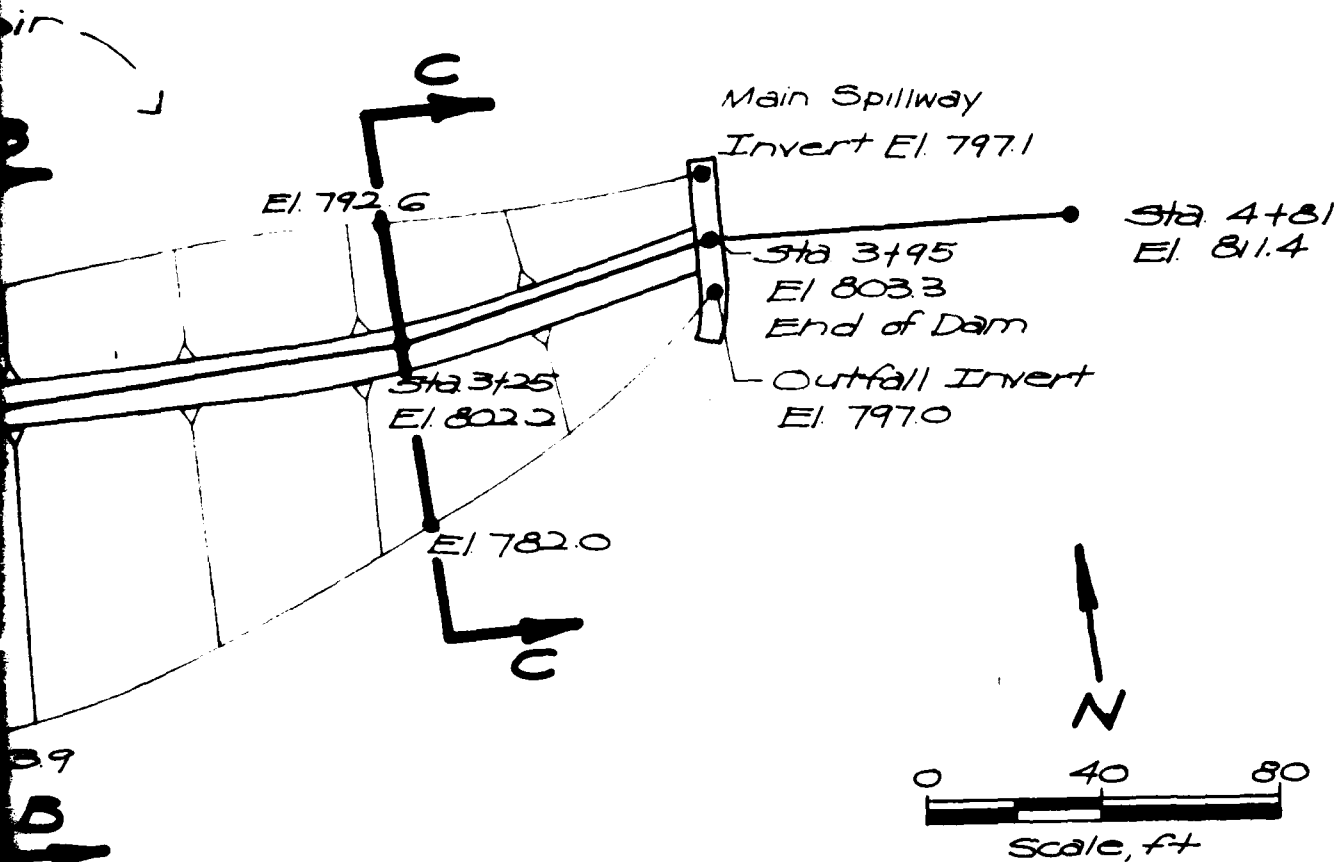
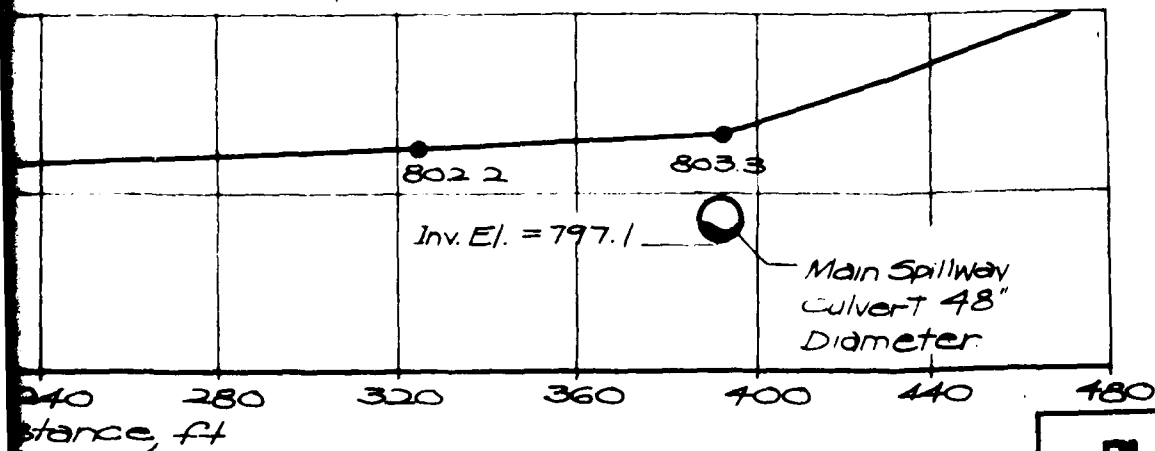
Fig. 3-A

- a. Visual inspection. The visual inspection identified no signs of cracking, sinkhole development, or animal burrows on the embankment. The field survey noted minor settlement had occurred near the center of the embankment (Fig. 3A). Seepage was noted at the toe of the dam. This was reported by Mr Hunt as a spring which existed prior to the building of the dam. If this is the case, it does not appear that any special precaution was taken during construction to install a filter over the spring. Total seepage flow was estimated at 5 gal/min. The seepage water did not appear to be transporting any soil, and was not considered to pose a hazard to the stability of the dam at the time of the inspection.
